**HISTORIC INVENTORY SURVEY
Hyattsville Historic District
FY 1997 Community Development Block Grant Program
Tipp City, Ohio**

**Municipality of Tipp City
Tipp City, Ohio
in conjunction with**

23 June 1999

**PATRICK A. HANSFORD ASSOCIATES
Centerville, Ohio**

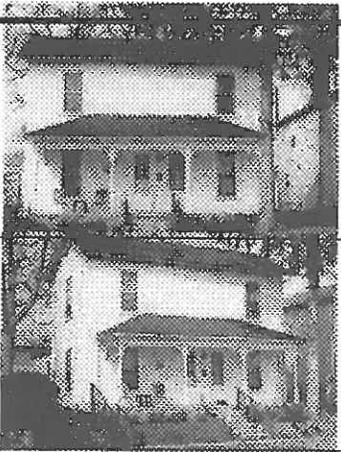
25. Owner's Name & Address, if known Nelson C. Borchers	
		26. Property Acreage 0.12 ac.	
		27. Other Surveys in Which Included	
42. Further Description of Important Interior and Exterior Features (Continue on reverse if necessary) Plan shape is rectangular with additions. Symmetrical front facade. One 2/2 double-hung window and one 1/1 double-hung window, one on either end of the first story, with two centralized doors. Victorian elements on the porch (columns and brackets). Three centralized steps up to the porch. Hip roof over porch. There are three additions. The first one is done in the same manner as the main house. Continued on reverse.

43. History and Significance (Continue on reverse if necessary) According to the tax records, Elizabeth Pickle was the owner in 1868 and there was a building on this lot. However, the lot is not numbered and she did not own the property before 1868. Without a lot number or a name of the owner, the descriptions are not good enough to follow back any further than 1868.

44. Description of Environment and Outbuildings (See #52) Flat site. Large evergreen trees to the northeast.			
45. Sources of Information See reverse for list of sources		46. Prepared by Reinhold/Hansford

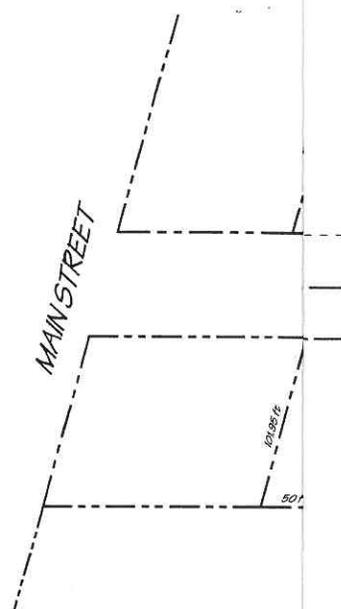
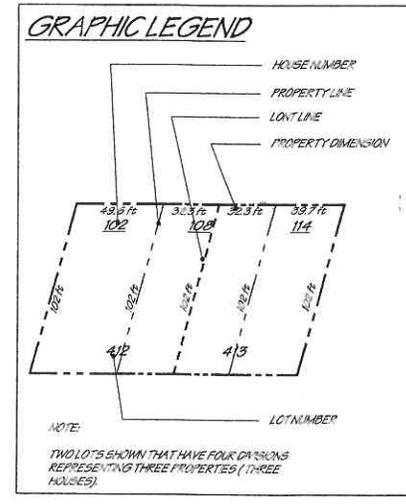
DISTRICT PLAN
SCALE: 1" = 50'

A map of the entire district was development using tax maps and aerial photography available from Miami County Map Department. Refer to Appendix Two.
